COUNTRY Czechoslovakia BUBJECT Ostrava Airfield PLACE ACQUIRED DATE ACQUIRED DATE ACQUIRED BY SOURCE DATE OF INFORMATION THIS IS UNEVALUATED INFORMATION			CONFI	DENTI	AL.	R	EPORT		
COUNTRY Czechoslovakia BUBJECT Ostrava Airfield NO. OF PAGES 8 PLACE NO. OF ENCLS. 3 (LISTED BELOW) DATE ACQUIRED SUPPLEMENT TO REPORT NO. THIS IS UNEVALUATED INFORMATION		The second secon		iii iiii e kmaiie		1			25
PLACE ACQUIRED DATE ACQUIRED BY SOURCE DATE OF INFORMATION THIS IS UNEVALUATED INFORMATION	COUNTRY	Czechoslova	kia			D	ATE DISTR.	26 oct.	
ACQUIRED OATE ACQUIRED BY SOURCE DATE OF INFORMATION THIS IS UNEVALUATED INFORMATION	SUBJECT	Ostrava Air	field	* *		N	O. OF PAG	ES 8	
DATE OF INFORMATION THIS IS UNEVALUATED INFORMATION	PLACE ACQUIRED		`			N (L	O. OF ENCL	.s. 3	
THIS IS UNEVALUATED INFORMATION	DATE ACQUIRED	BY SOURCE				SI R	UPPLEMENT EPORT NO.	то	2
	DATE OF IN	FORMATION				•			
			THIS IS UNEVA	LUATED INFOR	MATION				2

3. OSTRAVA AIRFIELD.

II. <u>SITE LAYOUT</u>:

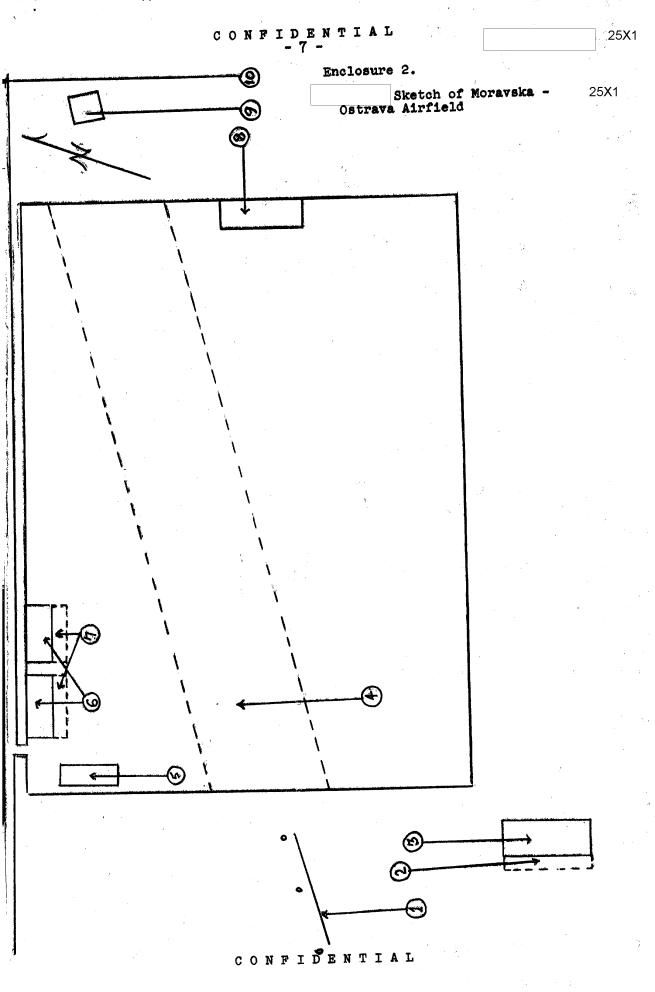
- 1. APPROACH LIGHTS: Four to five yellow lights mounted on wooden posts five meters high and spaced at 50 meter intervals. They were located 100 meters from start of runway 040.
 - 2. APRON: Concrete, 50 x 10-15 meters.
- 3. HANGAR: Gray stuccoed brick, 50 x 20 x 12 meters with shed type roof. When SOURCE last saw the hangar in March 1953, it contained farm machinery.
- 4. RUNWAY: Grass, 040 and 220, 900 meters long, 150 meters wide. It accommodated DC-3 aircraft. This runway was slippery and muddy after rainfalls.

- 5. ADMINISTRATIVE BUILDING: Single story, wooden construction, painted dark green, 25 x 10 x 5 meters with a low pitched gable type roof. This building contained a passenger waiting room, airline office, canteen, rest rooms, briefing room, teletype room, meteorology office, office for the Czechoslovak Airlines airfield chief, and a garage. Teletype was used to exchange flight data and weather data with Prague-Ruzyne airfield. It also contained a radio set (type unknown) and had radio antennas on the roof.

- 6. HANGARS: Stuccoed brick construction, 30 x 15 x 10 meters and had a shed type roof. The hangars were used for housing light Doslet Aircraft (Bieker C-104 and C-106 and gliders). It was also used for light maintenance.

- 7. APRONS: Concrete, approximately 30 meters long 10 meters wide.
- 8. HANGAR: It housed Doslet gliders and a goniometer and transmitter-receiver set which were used for voice and telegraph; it operated on 3255 kc. for voice and 322 kc, for telegraph letdown.

- 9. LORENZ UNIT: (BUILDING): single story, wooden construction, 3 x 3 x 3 meters and had a flat roof. A Lorenz antenna was located on the top of this building. (RC+1258, Encl. C., Sketch of Lorenz Unit). The Lorenz unit operated on a frequency of 33.3 mc and was used as a landing aid.
- 10. ROAD: two lane, dirt, one kilometer long, five meters wide, joined road Pt.#2, Encl. #1.
- 11. AIRFIELD ENTRANCE: This entrance was without a barrier and unguarded.

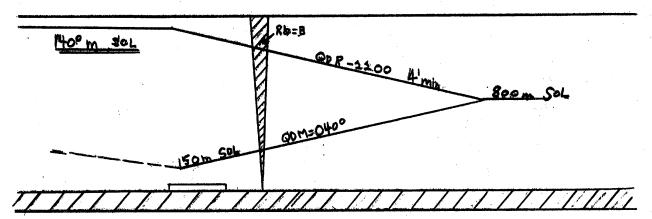
Enclosure 3.

Reference Encl. #2, Landing Procedure.

Diagram of Landing Procedure
